Client: Reginal Jose
Property: 2620 Main St
Roseville, MI 48066

Type of Estimate: Backup of Sewer or Drain
Date Entered: 8/13/2014 Date Assigned: 8/13/2014
Date Est. Completed: 2/9/2015 Date Job Completed:

Price List: MIDE8X_AUG14
Labor Efficiency: Restoration/Service/Remodel
Estimate: JOSE_REGINAL-RECON
File Number: 14-19949

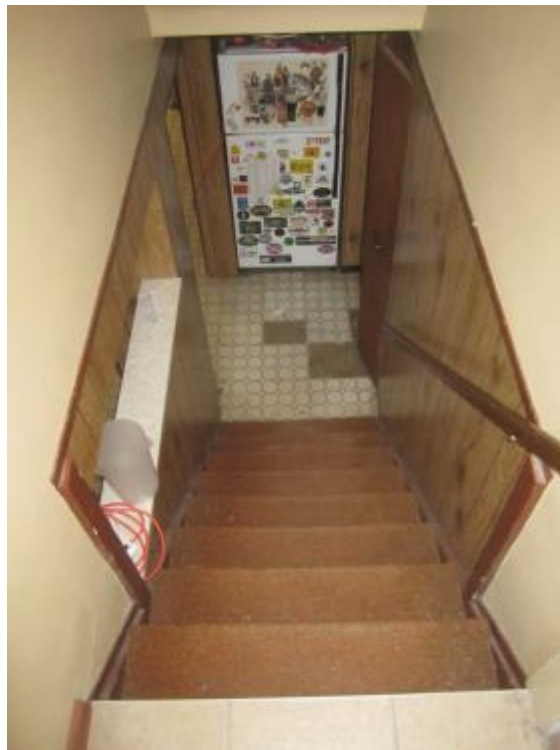
3 Dwelling/Basement/Stairs - Stairs
(3)

Detach & reset railing to R&R paneling

3. Handrail - wall mounted - Detach & reset	7.00 LF		0.00	5.30	0.00	7.42	44.52
<i>To R&R paneling</i>

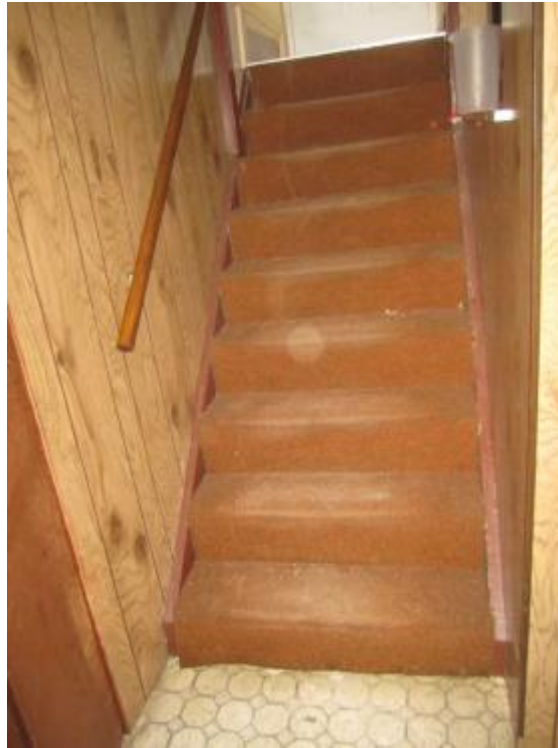
4 Dwelling/Basement/Stairs - Stairs -
Lower

Carpet was wet from heavy traffic and dripping water while removing contents from the basement during flood. Carpet adhesive on bottom riser separated from soaking in standing water. Paneling has water staining from Cat 3 storm/sewage water and has warped and swelled in many areas along the lower perimeter of the finished basement

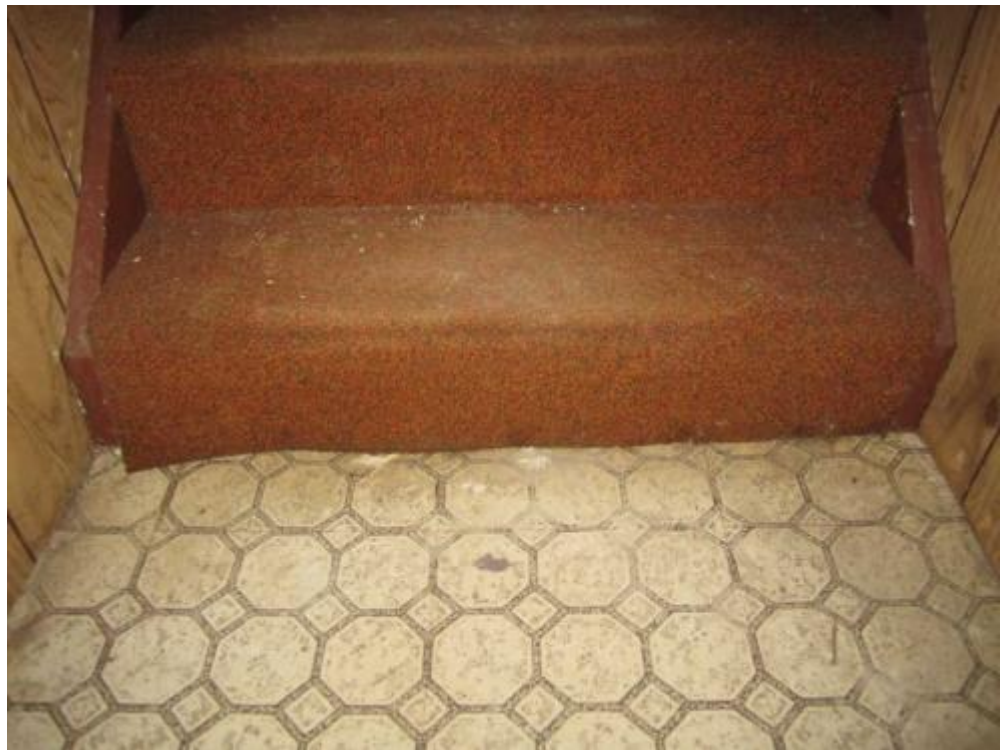
5 Dwelling/Basement/Stairs - Stairs
(4)

Damaged & contaminated carpet on
steps

4. Remove Carpet - Standard grade	38.14 SF		0.25	0.00	0.00	1.90	11.44
-----------------------------------	----------	--	------	------	------	------	-------

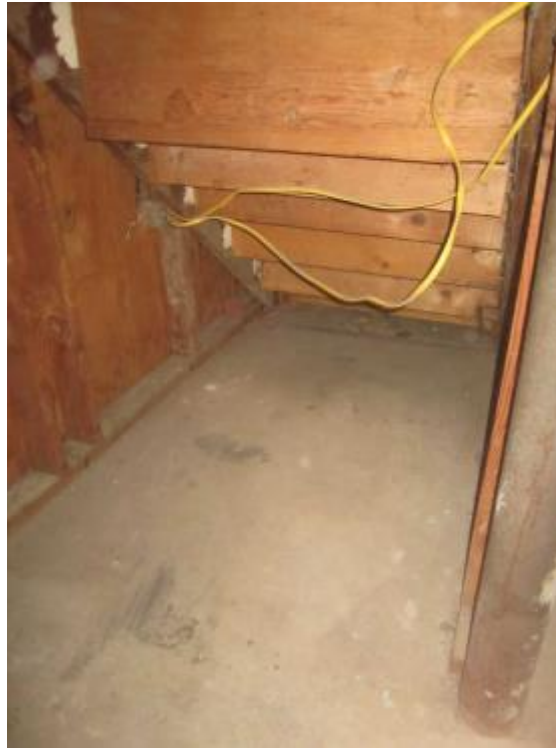
6 Dwelling/Basement/Finished
Basement - Finished - North

Finished basement area.
Floors are 12" vinyl tile and were installed using contact cement applied with roller.
Walls are plywood paneling with pre-finished veneer face ply and v shaped grooves. Paneling runs above drop ceiling to 7' height.
Panel moldings are 3/4" printed woodgrain plastic outside and inside corners.
Closet doors are stained mahogany.
(2) bifolds are hollow core with flush surface. (2) bifolds are solid wood frames with full louvers
Base is 2 1/2" vinyl cove.
Drop ceiling is aluminum grid, 2' x 4' fiberglass acoustic tiles with vinyl face covering.

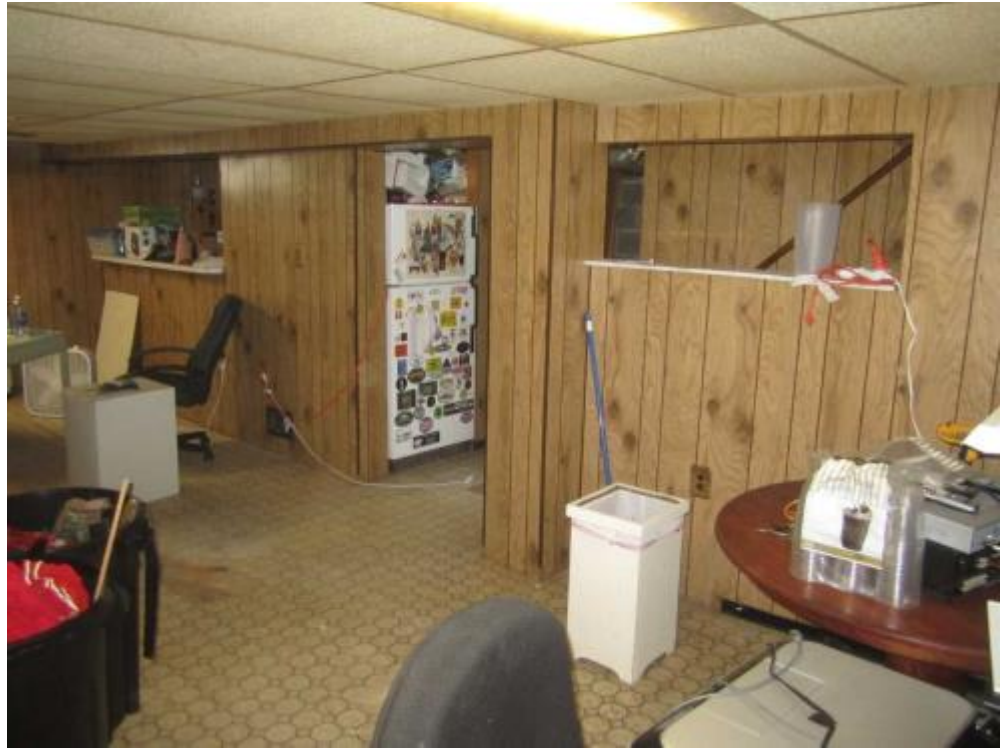
8 Dwelling/Basement/Finished
Basement - Finished - Bar Area
Date Taken: 8/14/2014
Taken By: Tom Balmes

Bar area has (2) wall sconce light
fixtures that will need to be D&R for
paneling R&R.
D&R exhaust vent cover to remove
ceiling tile

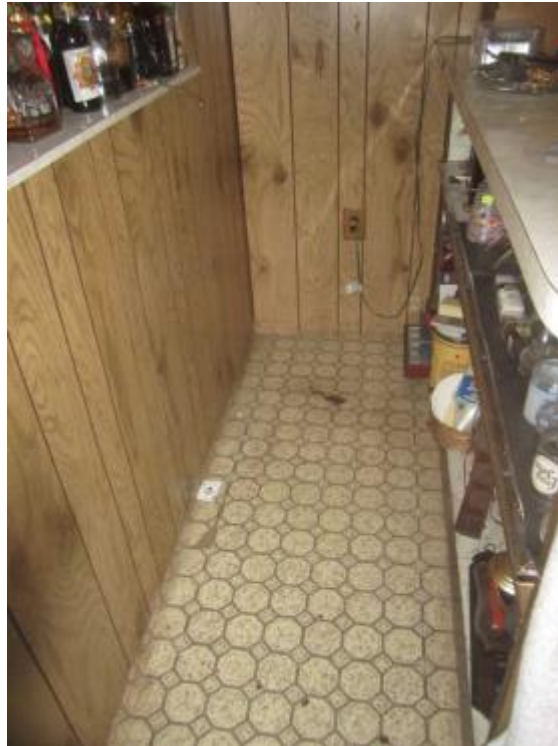
10 Dwelling/Basement/Finished
Basement - Finished - Bar
Date Taken: 8/14/2014
Taken By: Tom Balmes

Lower laminated plywood shelf D&R
to treat and clean floor beneath bar.
Loose and curled tiles observed on
floor behind bar.

DESCRIPTION	QTY	RESET	REMOVE	REPLACE	TAX	O&P	TOTAL
16. Detach & Reset Shelving - 12" - in place <i>Bottom shelf under bar to clean floor</i>	6.00 LF	7.09	0.00	0.00	0.01	8.50	51.05
FINISHES & HARDWARE

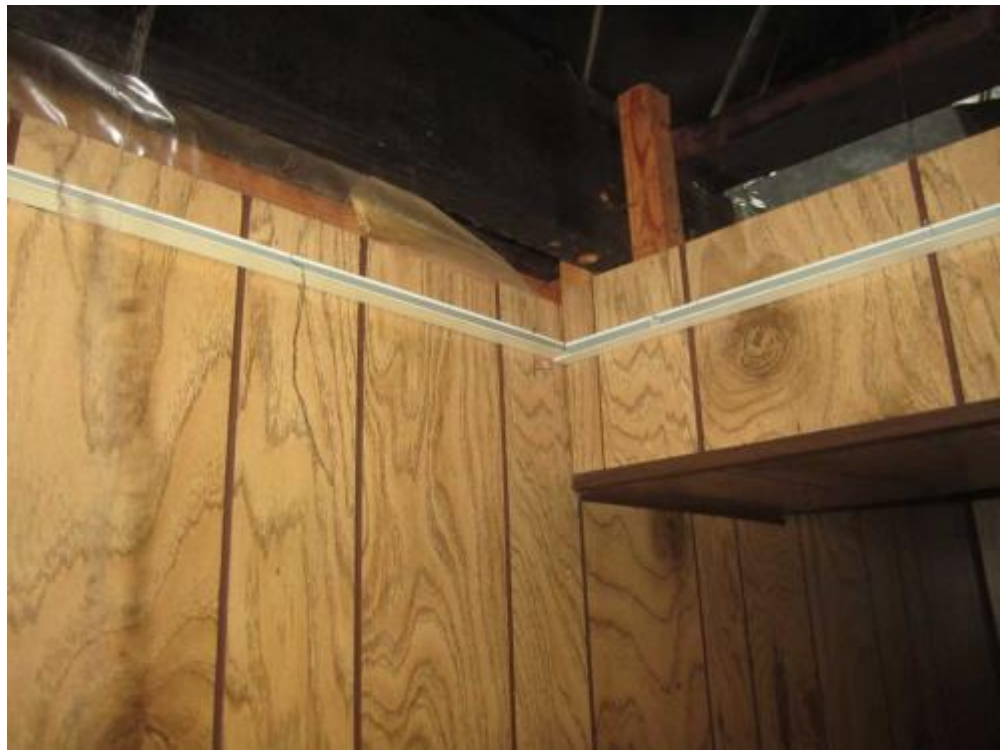
Drop ceiling grid is fastened through
wall paneling around perimeter of
finished section of basement. D&R
drop ceiling to replace paneling

10. Suspended ceiling grid - Detach & reset	318.24 SF		0.00	0.93	0.00	59.20	355.16
---	-----------	--	------	------	------	-------	--------

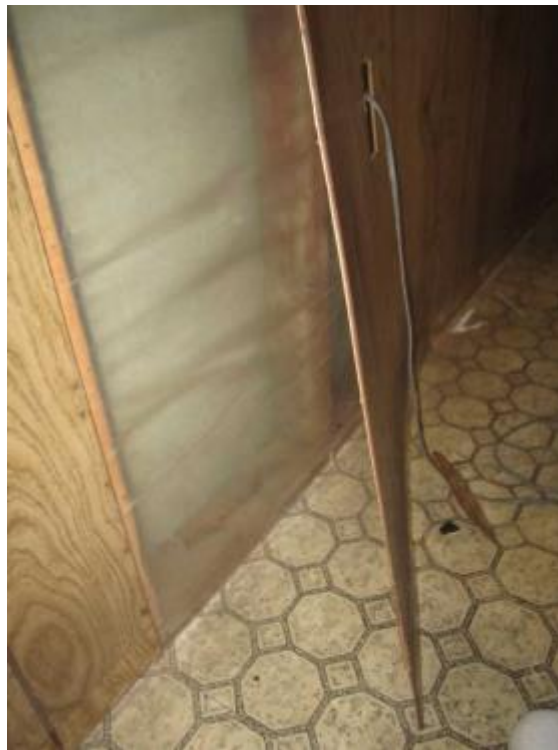
- 16 Dwelling/Basement/Finished
Basement - Wall Cavity
Date Taken: 8/14/2014
Taken By: Tom Balmes
Plastic sheathing vapor barrier over framing behind paneling on east wall of finished area. Wall is not insulated.

8. R&R Vapor barrier - visqueen - 6mil	347.07 SF		0.08	0.32	1.04	27.98	167.85
--	-----------	--	------	------	------	-------	--------

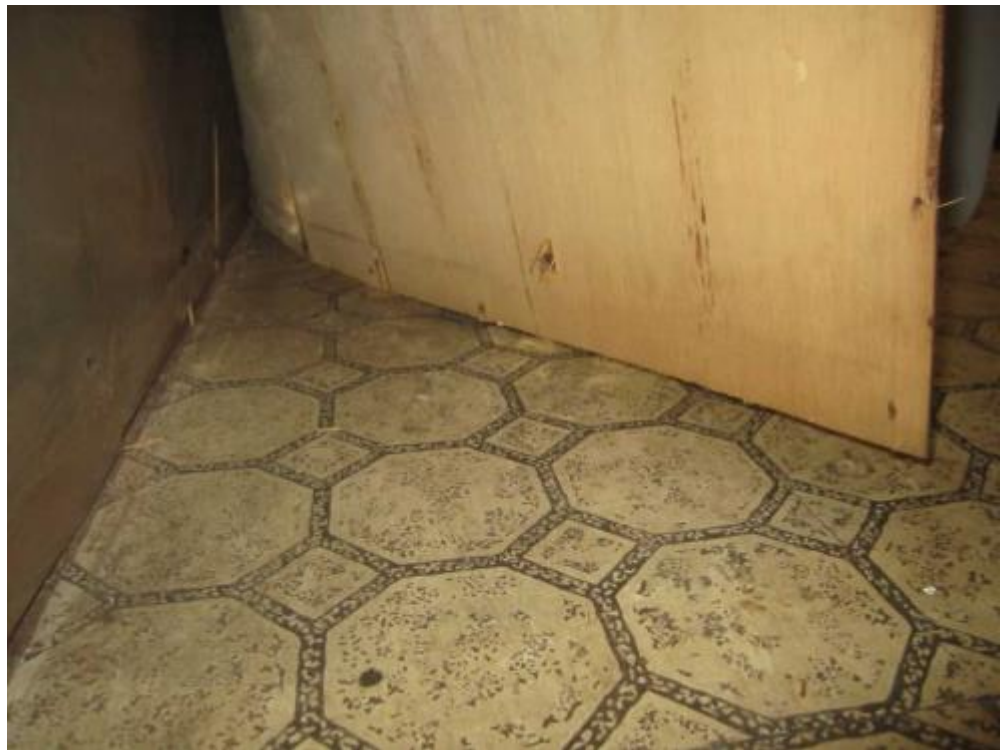
18 Dwelling/Basement/Finished
Basement - Paneling (back)
Date Taken: 8/14/2014
Taken By: Tom Balmes
Paneling is 1/8" x 4' x 8' plywood
sheet natural wood veneer with v-cut
grooves.

11. R&R Paneling - High grade	652.88 SF		0.27	2.30	28.60	341.30	2,047.80
-------------------------------	-----------	--	------	------	-------	--------	----------

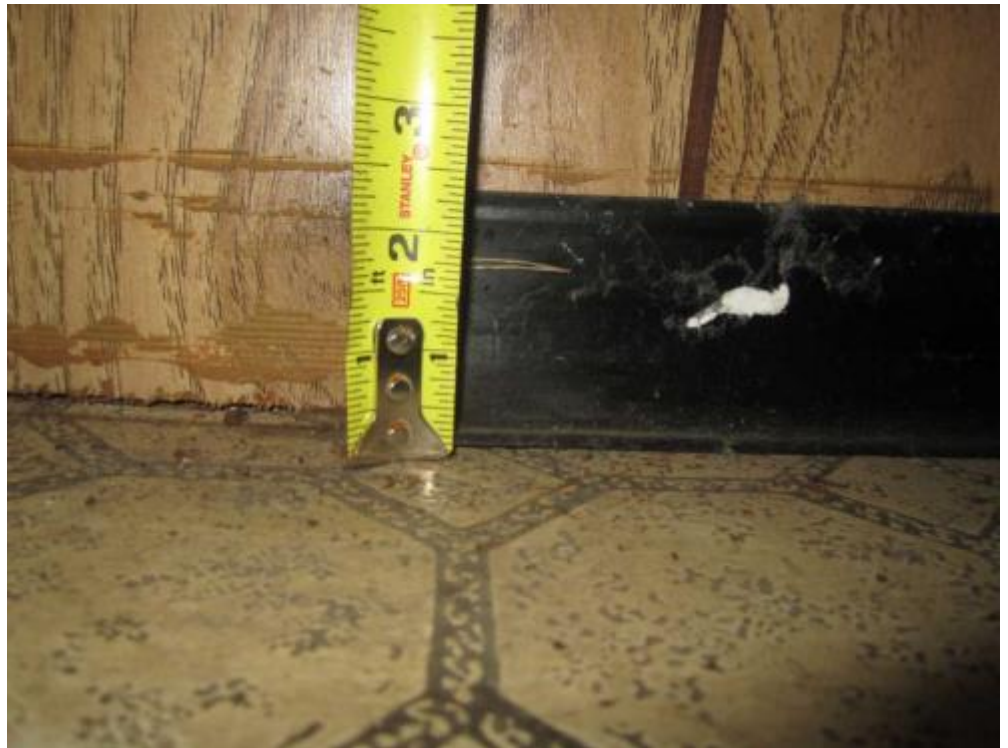
24 Dwelling/Basement/Finished
Basement - Drapery & Hardware
Date Taken: 8/16/2014
Taken By: Tom Balmes

Curtains, rod, & mounting hardware
D&R for paneling R&R

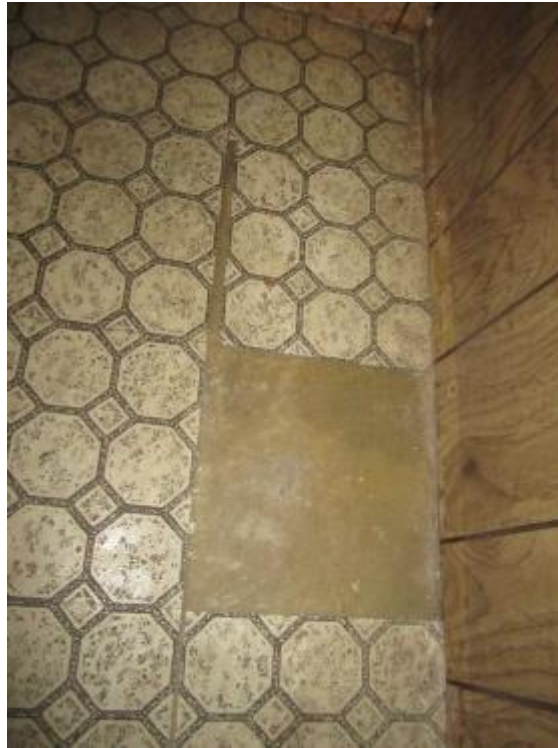
26 Dwelling/Basement/Finished
Basement - Floor Tile
Date Taken: 8/14/2014
Taken By: Tom Balmes

Loose tiles near northeast corner of finished basement area. Over 40 tiles were easily observed to be loose or curled up at edges throughout finished basement area.

25. Tear out non-salv vinyl, cut & bag - Category 3 water	320.43 SF		1.28	0.00	1.35	82.32	493.82
26. Clean floor	328.01 SF		0.00	0.31	0.00	20.34	122.02
27. Floor preparation for resilient flooring	320.43 SF		0.00	0.53	1.92	34.34	206.09

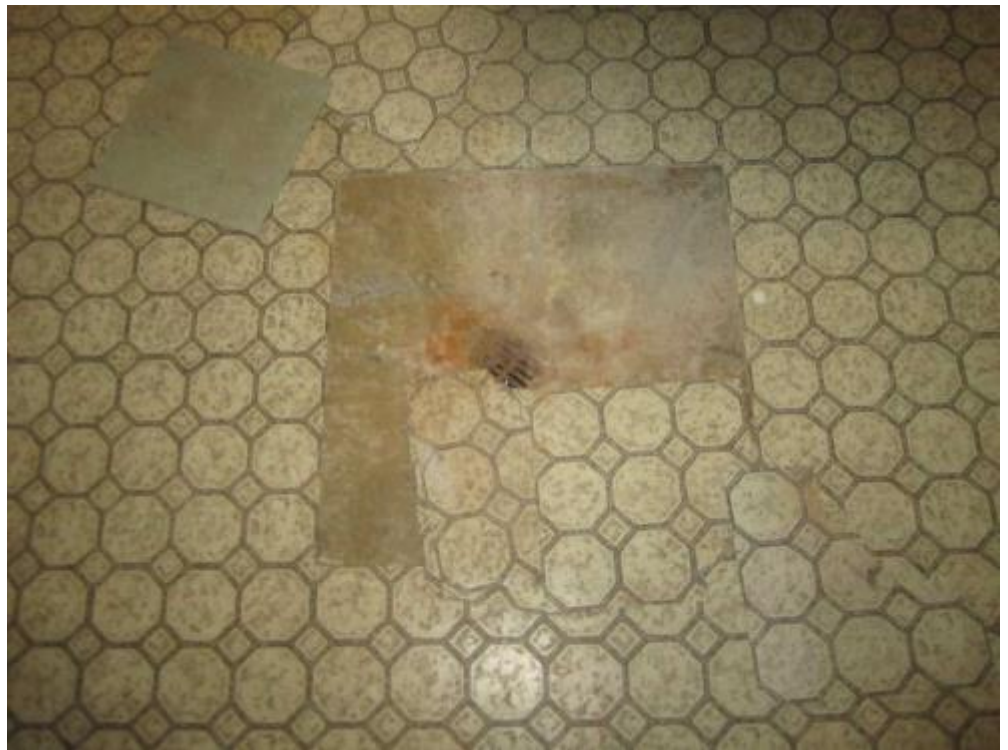
27 Dwelling/Basement/Finished
Basement - Floor Tile

Loose and damaged vinyl tiles around floor drain

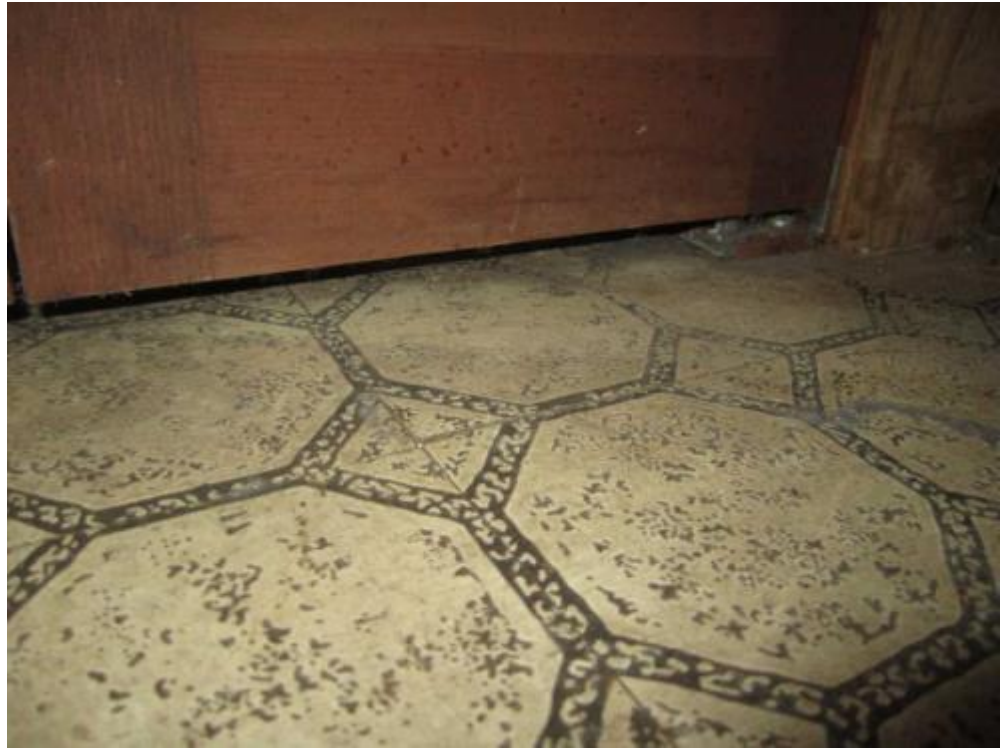
30 Dwelling/Basement/Finished
Basement - Louvered Bifold
Date Taken: 8/14/2014
Taken By: Tom Balmes

Water staining on bifold door to closet
on center of east wall

17. Stain & finish single bifold door - slab only - (per side) <i>Both sides of bifold doors are stained</i>	2.00 EA		0.00	25.58	0.79	10.40	62.35
18. Stain & finish full louvered door slab only - (per side) <i>Both sides of two fully louvered bifold doors</i>	4.00 EA		0.00	43.46	2.18	35.20	211.22

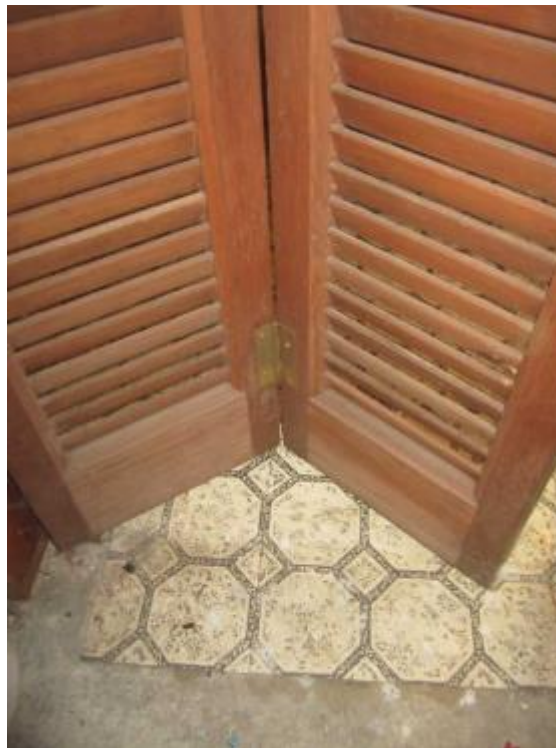
31 Dwelling/Basement/Finished
Basement - Louvered Bifold
Date Taken: 8/14/2014
Taken By: Tom Balmes

Water staining on bifold door to closet
at southeast corner of finished
basement

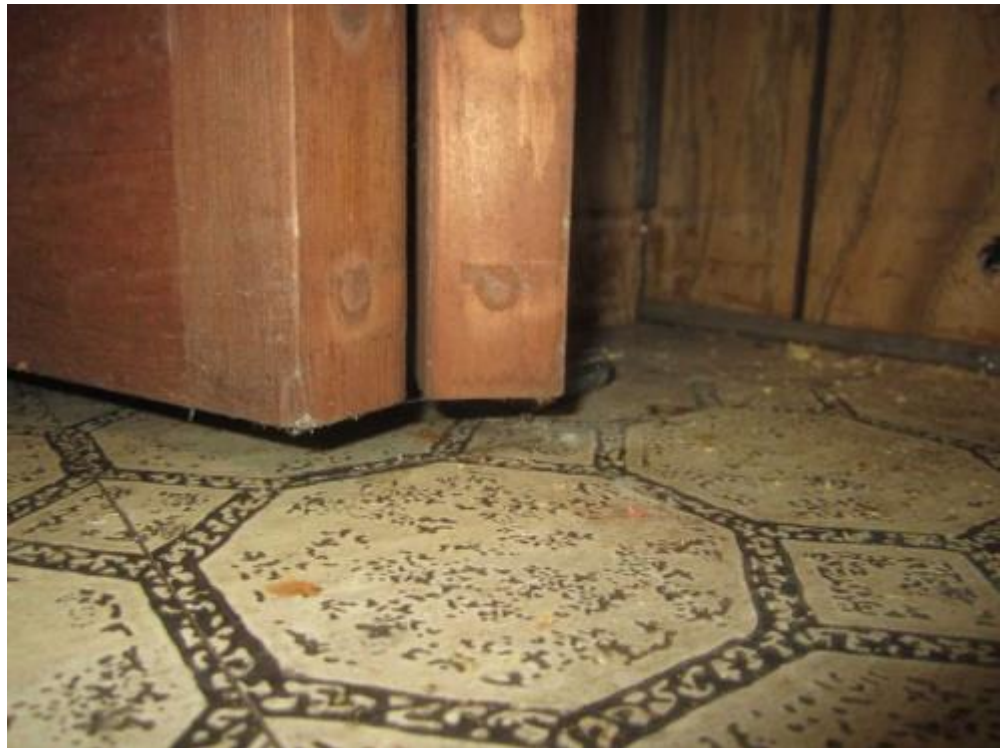
32 Dwelling/Basement/Laundry
Room - Laundry Room (5)
Date Taken: 8/14/2014
Taken By: Tom Balmes

Water staining on bifold door to closet
at southeast corner

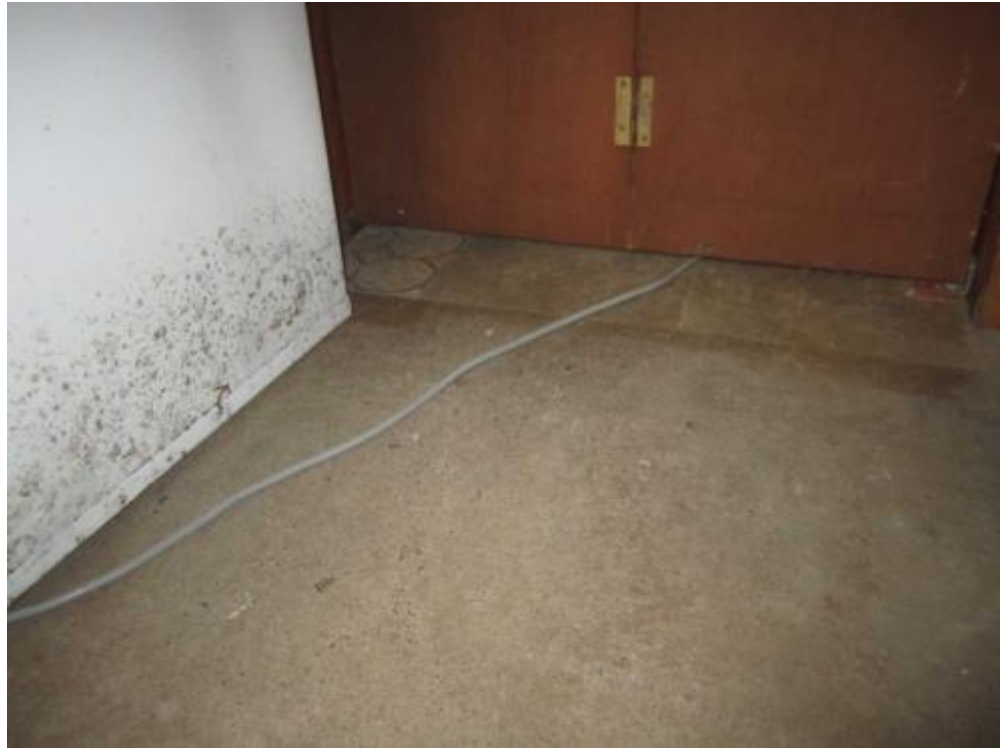
38 Dwelling/Basement/Laundry
Room - Laundry Room (6)
Date Taken: 8/14/2014
Taken By: Tom Balmes

Grime from storm water on bottom of
freezer to right of door to finished
area of basement

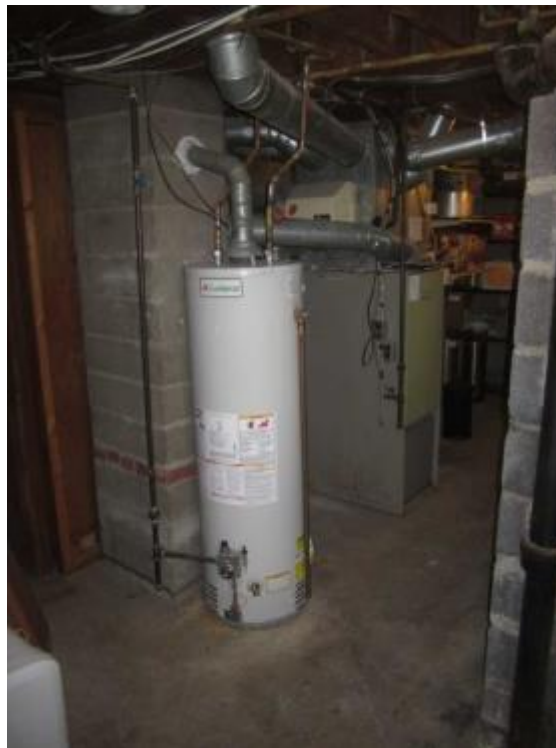
39 Dwelling/Basement/Laundry Room - Laundry Room (8)
Date Taken: 8/14/2014
Taken By: Tom Balmes

Standing water extinguished pilot light on water heater

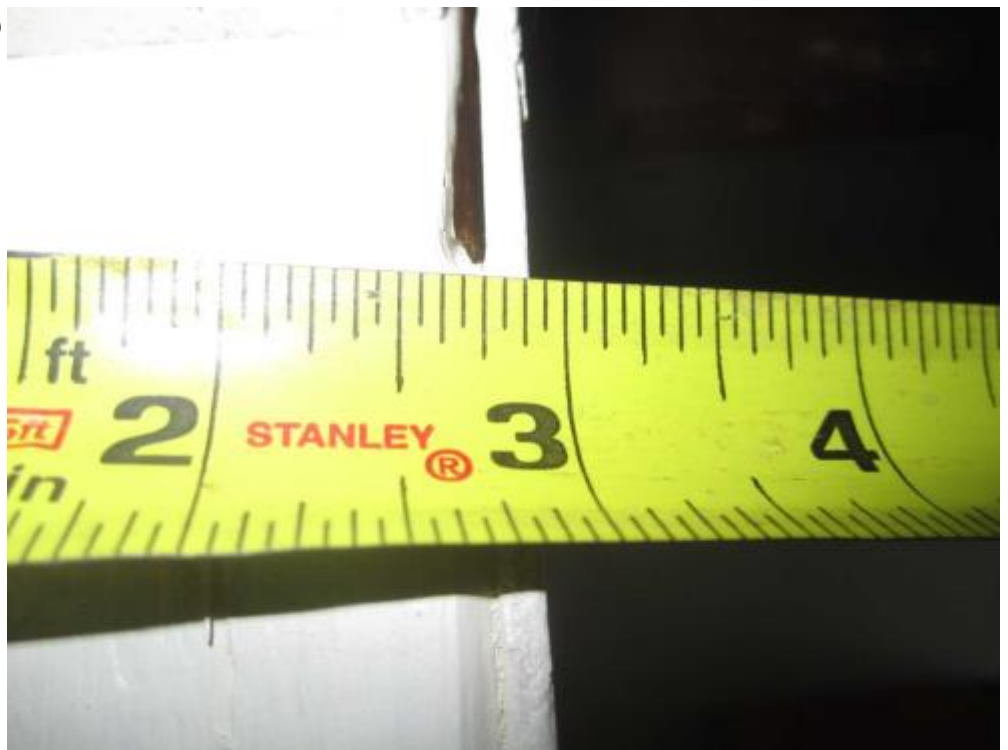
40 Dwelling/Basement/Bathroom (3/4) - Bathroom (1)
Date Taken: 8/14/2014
Taken By: Tom Balmes

1/8" plywood wall coverings in bathroom

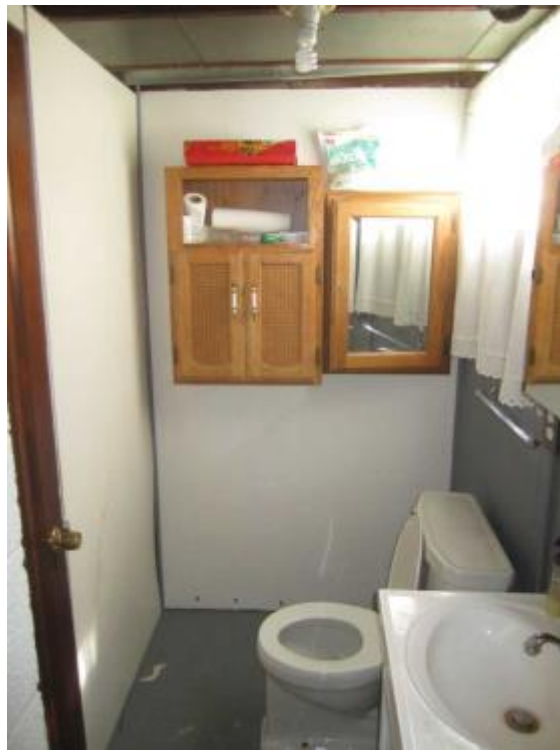
43 Dwelling/Basement/Bathroom (3/4)
- Bathroom (4)

Painted plywood on south and east walls with 14' of painted QR inside corner molding. D&R (2) medicine cabinets for wall repairs

39. R&R AC plywood - 1/4"	53.92 SF		0.33	1.88	2.94	24.42	146.52
40. R&R Quarter round - 3/4"	14.00 LF		0.15	1.22	0.40	3.92	23.50
41. R&R Vanity	1.50 LF		6.64	129.12	8.82	42.50	254.96
FINISHES & HARDWARE

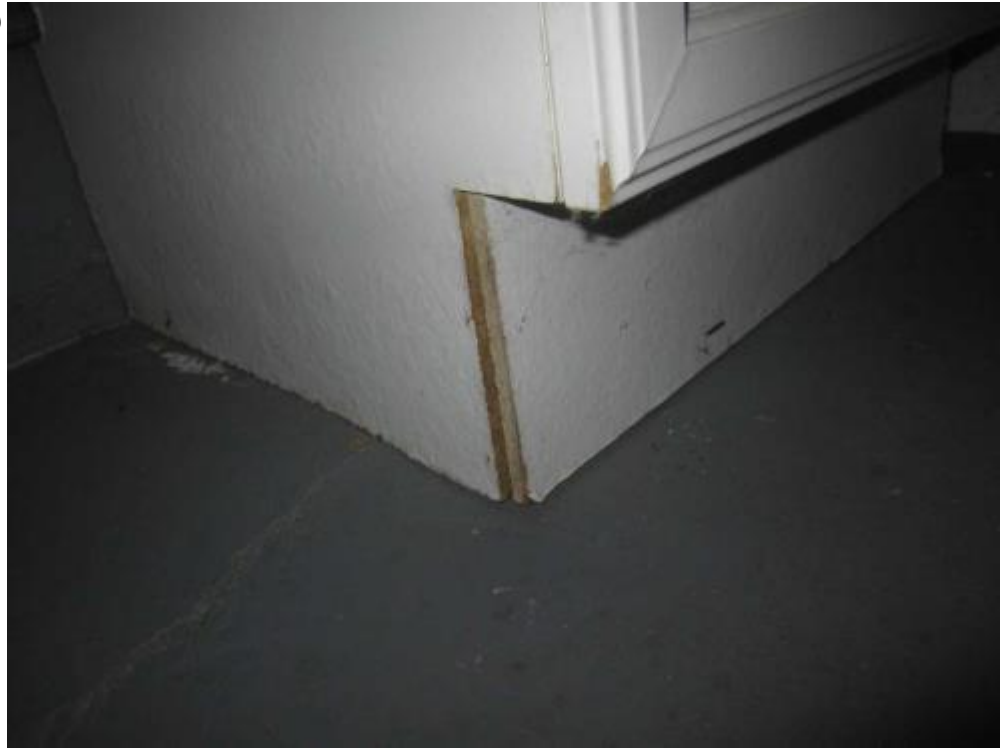
46 Dwelling/Basement/Bathroom (3/4)
- Bathroom (7)

Water damage to front kick panel and sides of vanity. Veneer is wrinkled from swelling & shrinking after soaking up standing water

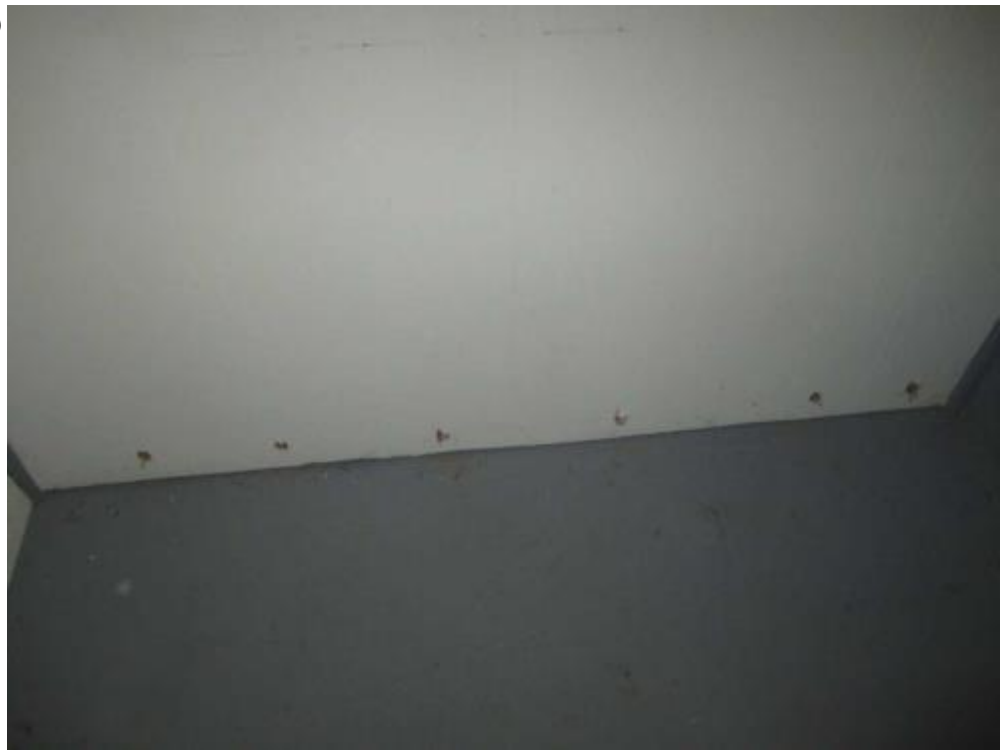
47 Dwelling/Basement/Bathroom (3/4)
- Bathroom (8)

Holes for dryout in south wall plywood covering. Panel is stained from several inches of standing water.

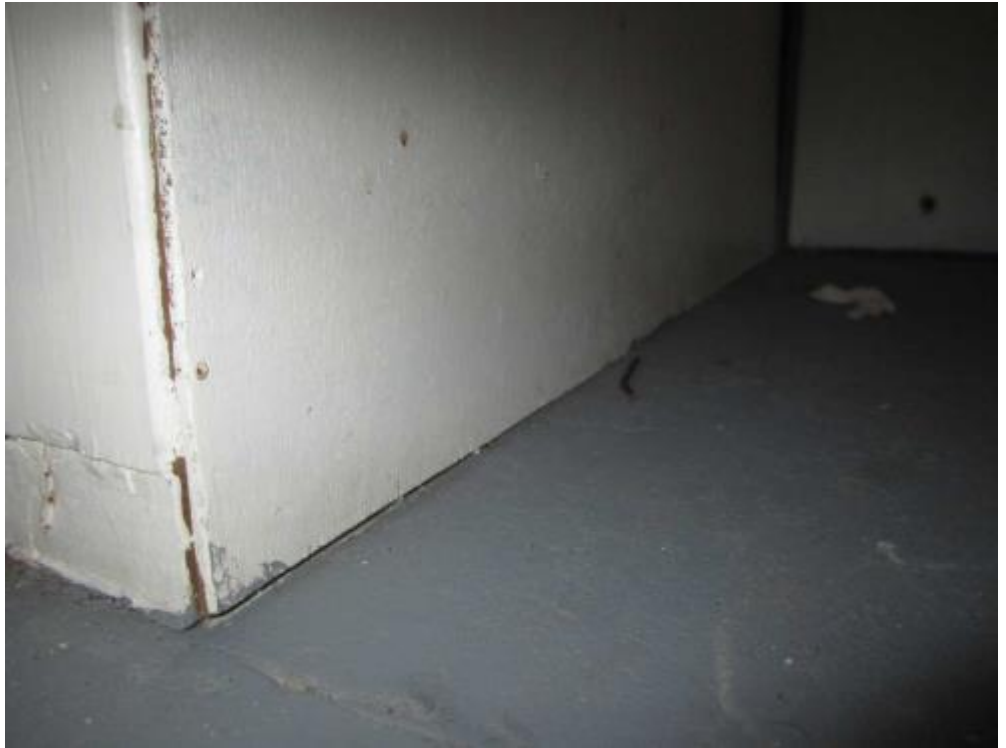
48 Dwelling/Basement/Bathroom (3/4)
- Vanity

Water staining to east bathroom wall
and framing at doorway

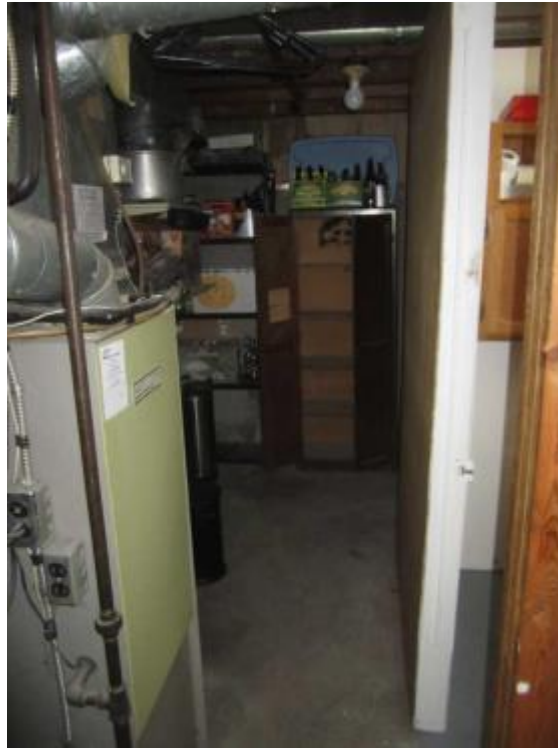
50 Dwelling/Basement/Storage -
Storage Area (4)

West wall of storage room and
paneled wall with water staining.
Adjustable shelving attached to south
facing plywood wall (right side of
photo)

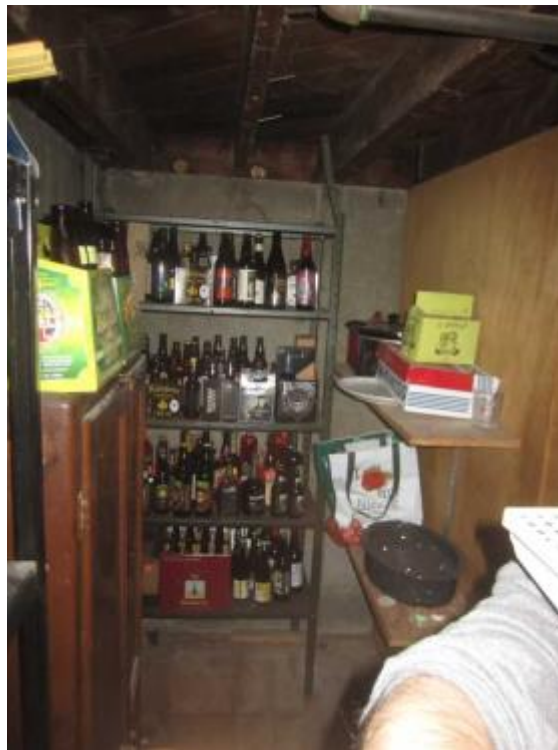
51 Dwelling/Basement/Storage -
Plywood panel

Water stained plywood wall covering
in storage room. Plywood panels
cover exterior bathroom wall framing.
Holes were drilled between studs for
mold/bacteria treatment and dry-out
